ABBREVIATED PRELIMINARY ASSESSMENT CHECKLIST

Site Name: Décor by Dene

Photo Documentation
Décor by Dene Off-site Reconnaissance
September 3, 2020

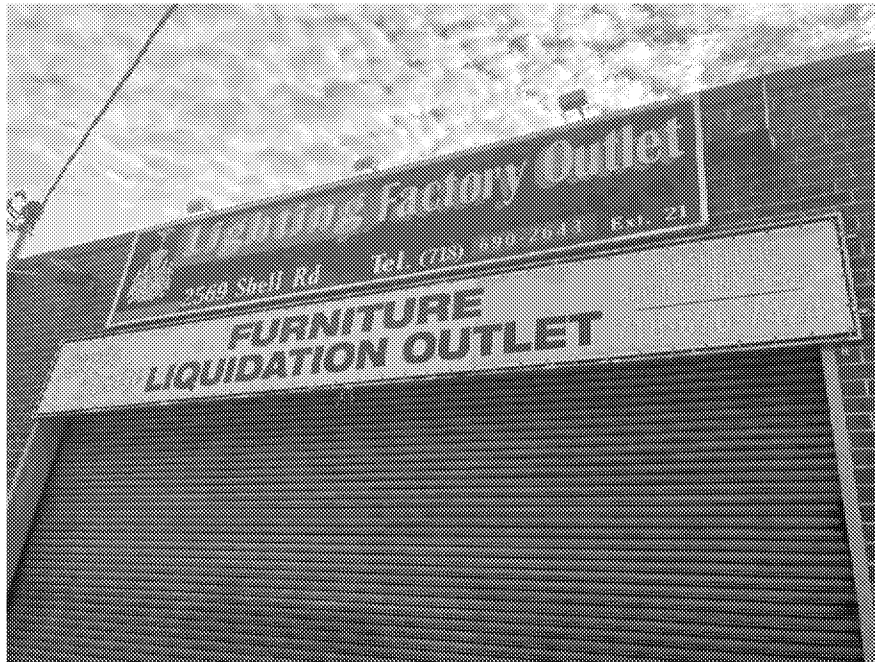
Photo No. 1: Sign for “Lighting Factory Outlet” at 2569 Shell Road, looking east while standing on the sidewalk bordering the building. Building previously occupied by Décor by Dene.

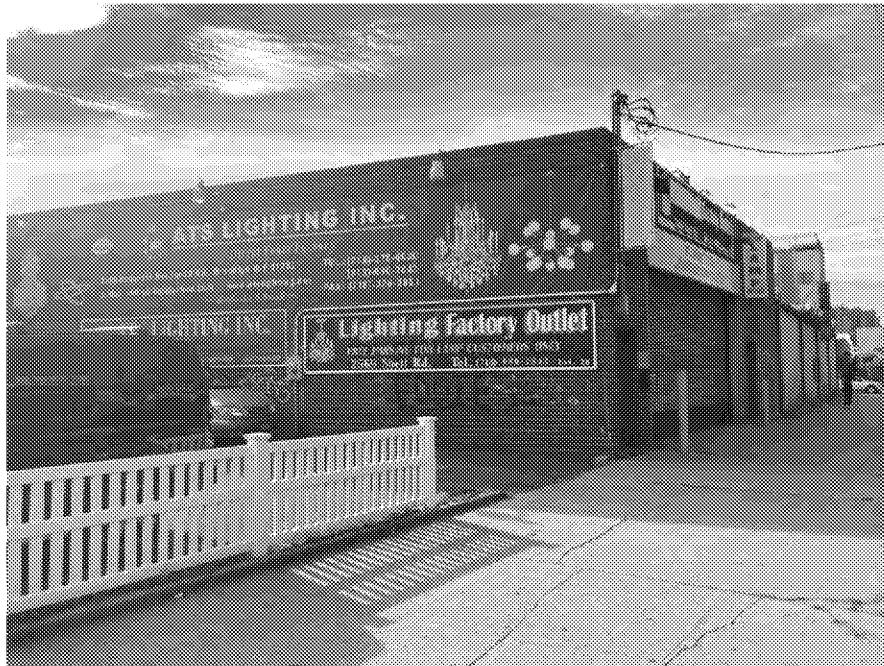
Photo No. 3: Signs for the retail lighting business on the northern wall of the building name the business “ATS Lighting Inc.”; looking southeast while standing on sidewalk in front of building.

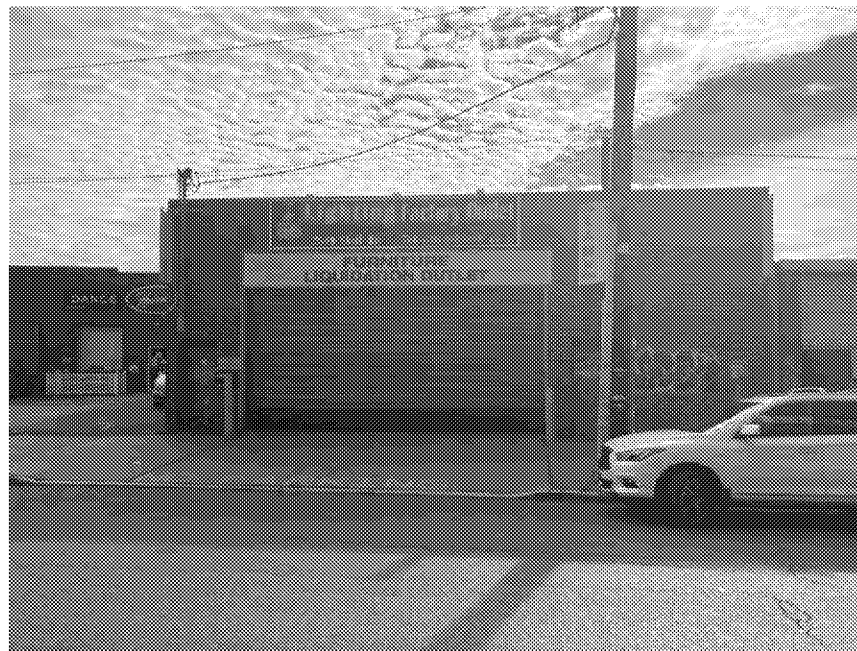
Photo No. 4: The retail lighting store occupies a one story brick building, and is bordered to the north by an asphalt parking lot, a dance studio, and a vacant commercial space. The building is surrounded by concrete and asphalt surfaces (sidewalks and parking areas). Looking east, standing across Shell Road.

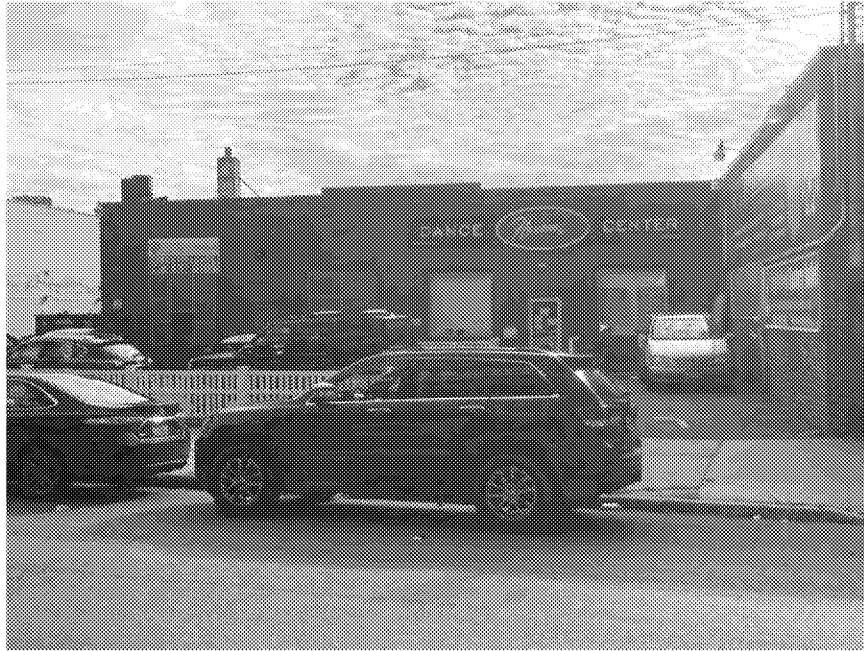
Photo No. 5: Parking lot and businesses bordering ATS Lighting Inc. to the north; one roll off dumpster located on the northern side of the building; looking east, standing across Shell Road.

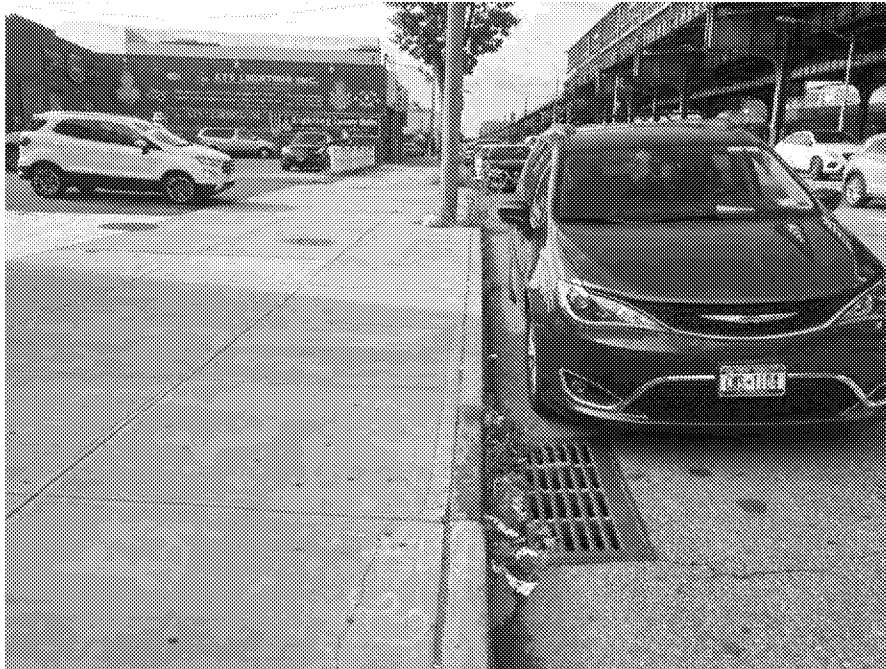
Photo No. 6: Nearest storm sewer located on the eastern side of Shell Road, north of the site; topography is generally flat; looking south.

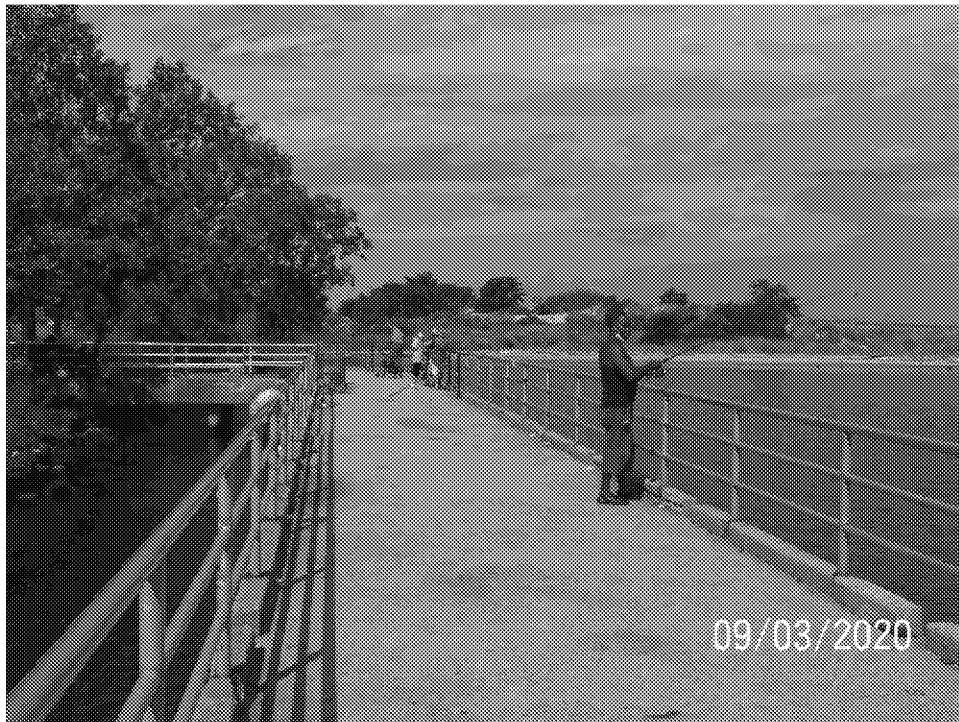
Photo Nos. 7 and 8: Multiple persons were observed to be fishing for consumption along the south side of Coney Island Creek at the Kaiser Park fishing pier. According to these residents, species of fish caught for consumption include blue fish, striped bass, and flounder. Resident at the far end of the pier was using both a fishing pole and a net.

1100 observe multiple people fishing at a public pier in Kaiser park along Cooney Island creek. SS collects GPS location. Interview two separate fishermen, both claim they eat some of their catch (species: Striped Bass, blue-fish, one said tuna but doesn't seem possible he may be mistaken).

Sign advising ~~boaters~~ ^{and} pregnant women not to eat "fish and eels" caught at the location. One fisherman ~~was~~
